WATERSHED AND REACH SCALE INVESTIGATION OF EXISTING CONDITIONS

MANASTASH CREEK CORRIDOR HABITAT ENHANCEMENT AND FLOOD HAZARD REDUCTION PLAN

Prepared for
Kittitas County Conservation District

May 31, 2013

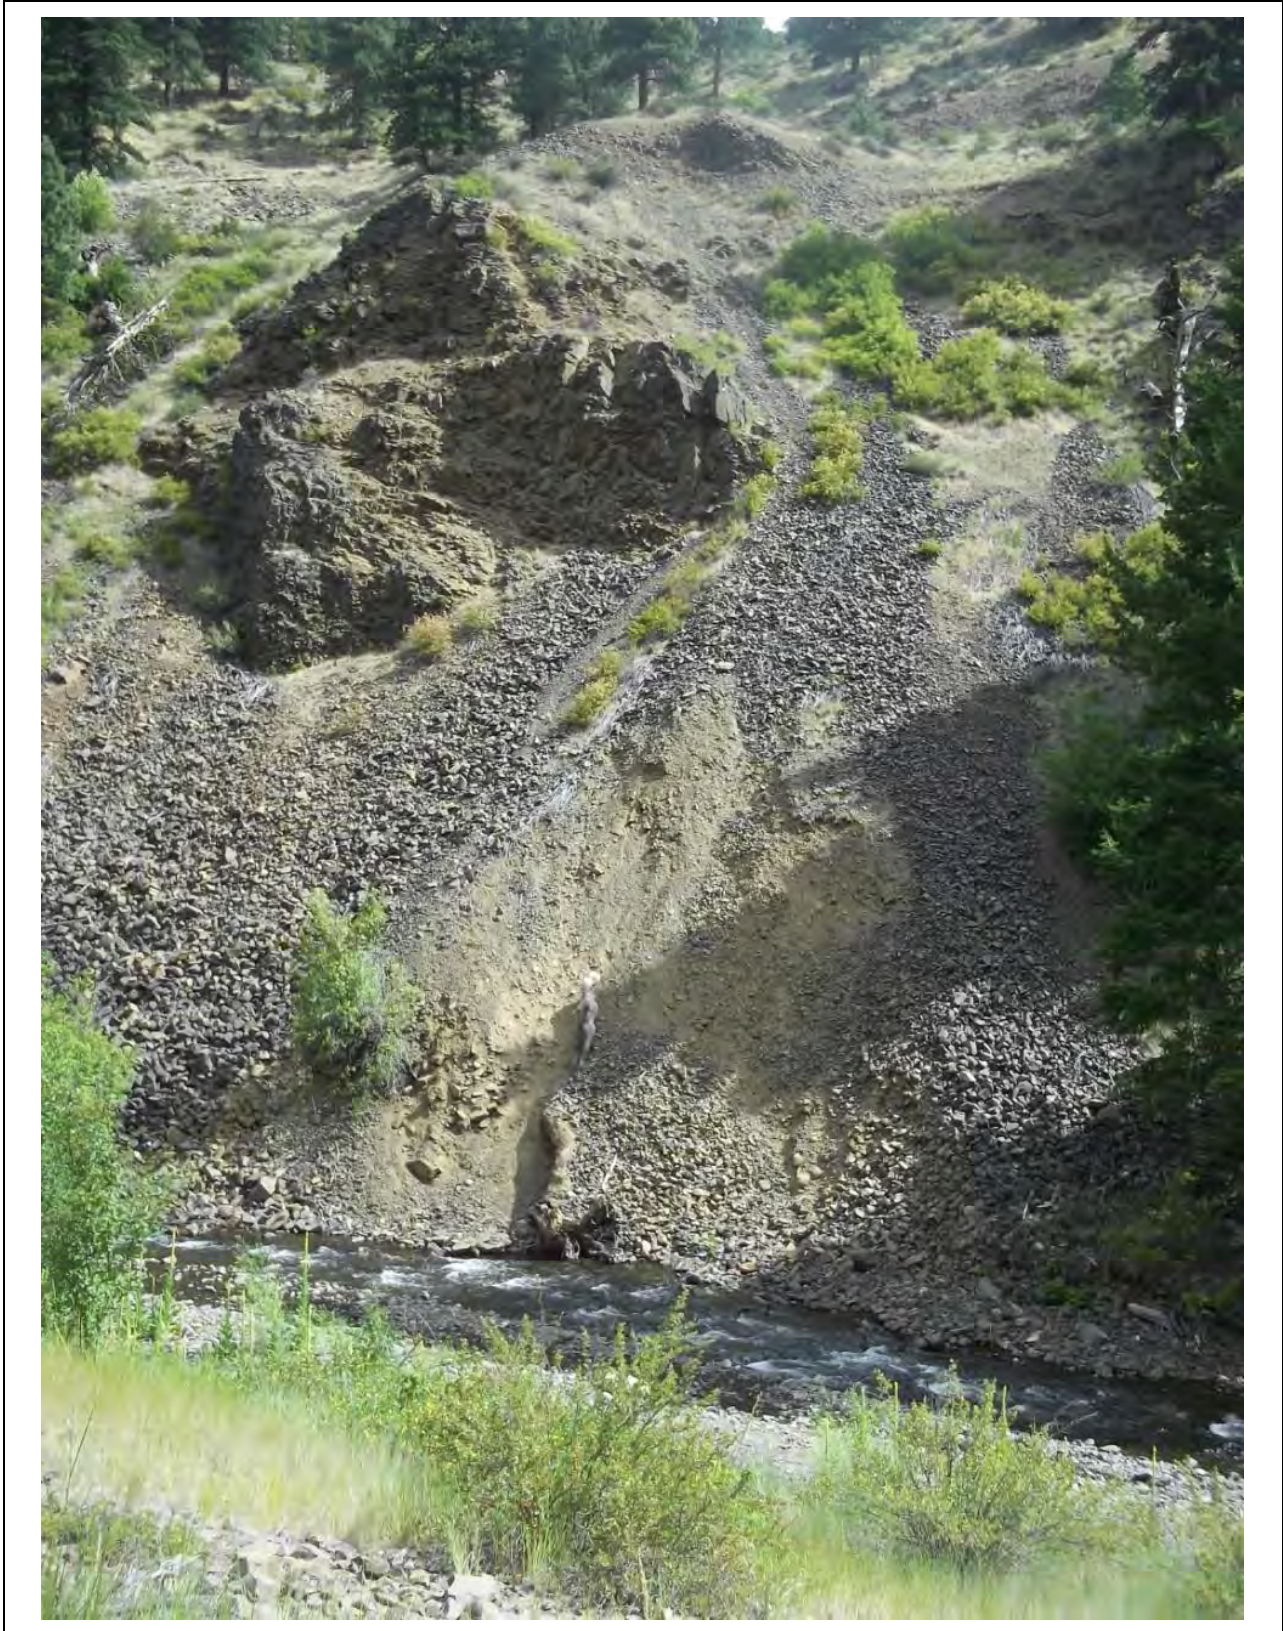
Figure 4. Photograph of Active Sediment Delivery in Manastash Canyon.
